DEPARTMENT OF TRANSPORTATION**DIVISION OF ENGINEERING SERVICES**

Contract #: 04-0120F4Cty: SF/ALA Rte: 80 PM: 13.2/13.9File #: 69.28**WELDING INSPECTION REPORT****Resident Engineer:**Pursell, Gary**Address:** 333 Burma Road**City:** Oakland, CA 94607**Report No:** WIR-012599**Date Inspected:** 10-Mar-2010**Project Name:** SAS Superstructure**OSM Arrival Time:** 1900**Prime Contractor:** American Bridge/Fluor Enterprises, a JV**OSM Departure Time:** 700**Contractor:** Zhenhua Port Machinery Company, Ltd (ZPMC), Changxing Island **Location:** Shanghai, China**CWI Name:** See Below**CWI Present:** Yes No**Inspected CWI report:** Yes No N/A**Rod Oven in Use:** Yes No N/A**Electrode to specification:** Yes No N/A**Weld Procedures Followed:** Yes No N/A**Qualified Welders:** Yes No N/A**Verified Joint Fit-up:** Yes No N/A**Approved Drawings:** Yes No N/A**Approved WPS:** Yes No N/A**Delayed / Cancelled:** Yes No N/A**Bridge No:** 34-0006**Component:** OBG and Tower**Summary of Items Observed:**

On this date CALTRANS OSM Quality Assurance (QA) Inspector, Mr. Paul Dawson, arrived on site at the Zhenhua Port Machinery Company (ZPMC) facility at Changxing Island, in Shanghai, China, for th

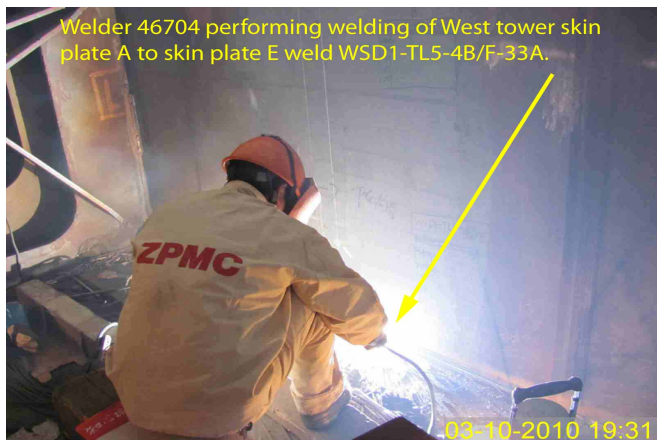
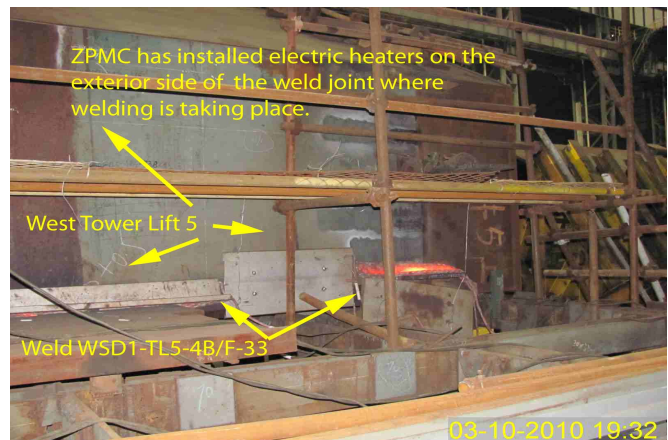
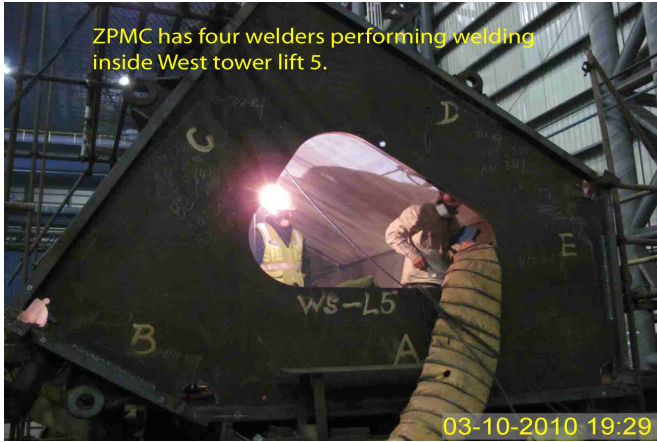
This QA Inspector observed ZPMC welder Mr. Chen Shang Chun, stencil 046704 is using welding procedure specification WPS-B-T-3212-TC-U5b-1 to make shielded metal arc weld WSD1-TL5-4B/F-33A between tower lift 5 skin plate A and skin plate E inside surfaces. This QA Inspector observed that the base material is being heated with an electric heater and ZPMC QC personnel are monitoring the base material temperatures. This QA Inspector observed ZPMC QC has recorded a welding current of 265 amps and this QA Inspector also measured a welding current of approximately 265 amps. Mr. Chen Xhang Chun appears to be storing his welding electrodes in a heated container. This QA Inspector observed Mr. Chen Shang Chun appears to be certified to make this weld. Items observed by this QA Inspector appear to be progressing in compliance with project specifications. See the photographs below for additional information concerning welding of West Tower Lift 5.

lift 5 skin plate A and skin plate E inside surfaces. This QA Inspector observed that the base material is being heated with an electric heater and ZPMC QC personnel are monitoring the base material temperatures. This QA Inspector observed ZPMC personnel have recorded a welding current of 256 amps and the welding electrodes are being stored in a heated container. This QA Inspector observed Mr. Cui Guozhong appears to be certified to make this weld. Items observed by this QA Inspector appear to be progressing in compliance with project specifications.

This QA Inspector observed ZPMC welder Mr. Hu Xing Ping, stencil 049099, is using welding procedure specification WPS-B-T-3212-TC-U4b-1 to make shielded metal arc weld WSD1-TL5-4B/F-39A between tower lift 5 skin plate B and skin plate C inside surfaces. This QA Inspector observed that the base material is being heated with an electric heater and ZPMC QC personnel are monitoring the base material temperatures. This QA Inspector observed ZPMC QC has recorded a welding current of 252 amps and the welding electrodes are being stored in a heated container. This QA Inspector observed Mr. Hu Xing Ping appears to be certified to make this weld. Items observed by this QA Inspector appear to be progressing in compliance with project specifications.

This QA Inspector observed ZPMC welder Mr. Yang Lei, stencil 040690 is using welding procedure specification WPS-B-T-3212-TC-U4b-1 to make shielded metal arc weld WSD1-TL5-4B/F-39A between tower lift 5 skin plate B and skin plate C inside surfaces. This QA Inspector observed that the base material is being heated with an electric heater and ZPMC QC personnel are monitoring the base material temperatures. This QA Inspector observed ZPMC QC has recorded a welding current of 271 amps and the welding electrodes are being stored in a heated container. This QA Inspector observed Mr. Yang Lei appears to be certified to make this weld. Items observed by this QA Inspector appear to be progressing in compliance with project specifications.
